Manhole Inspection Summary

Manhole # S35M__025MH

Location Address: **John L Deaton Pavillion**

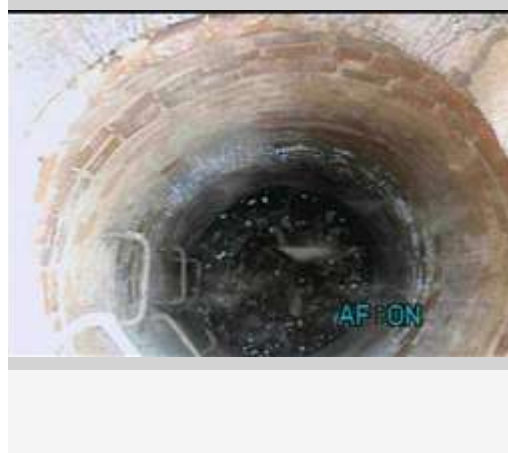
Top View

Comments **Filled up with debris can not even see the top of any pipes. Suppose to be an out at 12 & a house connection at 5.**

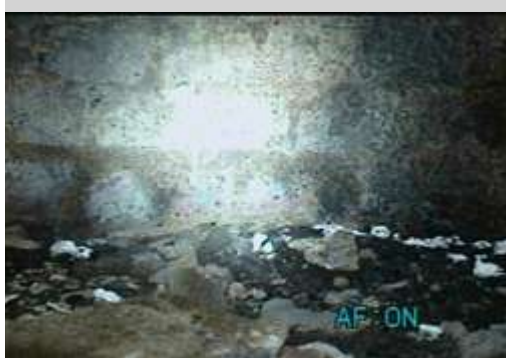
Defect 4

Condition: ☐ Sound ☐ Cracked ☐ Root Intrusion ☐ Deteriorated ☐ Leaks ☒ **Debris**

Channel debris at 5

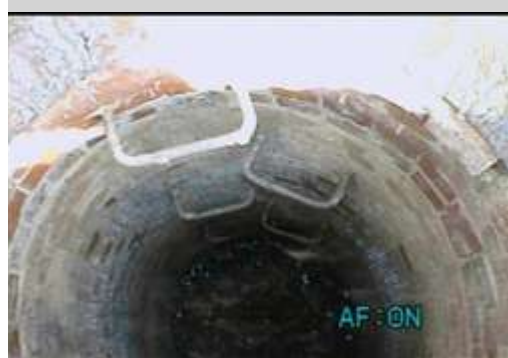
Defect 3

Count: **7** Missing: **0** ☒ **Corroded**

corroded Steps

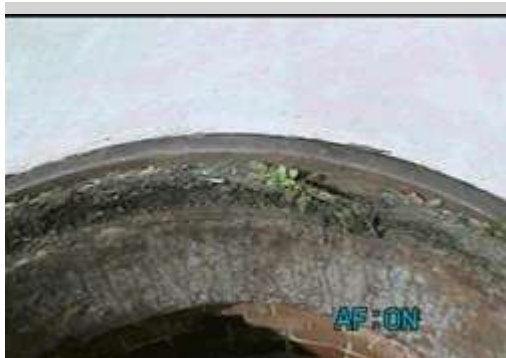
Defect 2

☒ **Leaks**

infiltration from cover

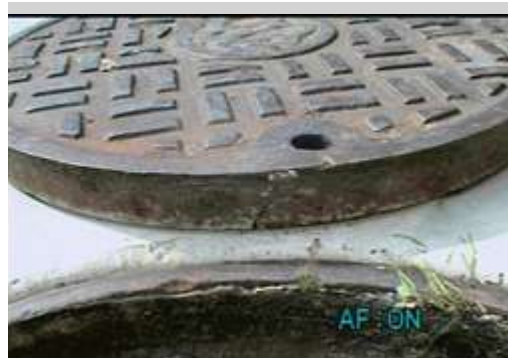
Defect 1

Condition: **Cracked**

Cracked cover

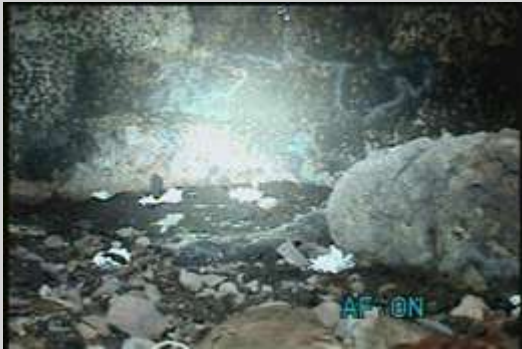
12 O'Clock Outflow

8 in. Circular Gravity Sewer
Pipe Out @ 12 O'Clock

Deposits: ☐ None ☐ Mud ☐ Sludge ☒ **Debris** ☐ Grease

Silt Depth: 16 (in.) Deposits Extent: **Heavy**
